HISTORIC STRUCTURE REPORT
for
THE OLD OCEAN COUNTY SHERIFF'S OFFICE
Toms River, Ocean County, New Jersey

Prepared by
Watson and Henry Associates
Bridgeton, New Jersey
Project 88-055

January 1992

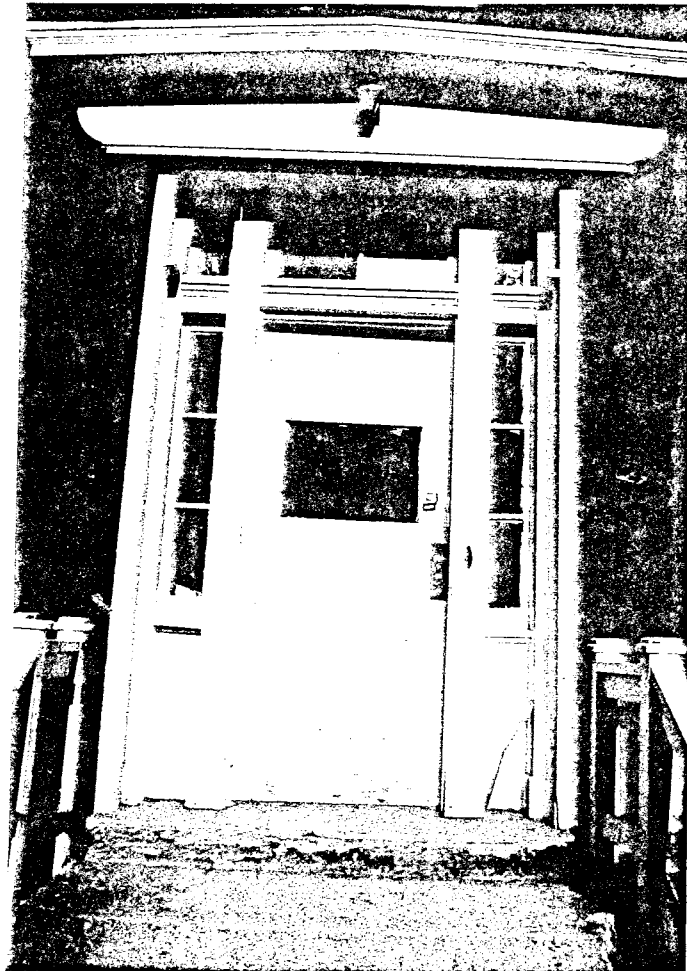
FIGURE 14
Front entrance (South)

The front door and doorway appear to be original to 1851 (Figure 14). The door has had two panels removed and glass inserted. The majority of the interior doors date from the 1923 renovation, with the exception of obvious late twentieth-century replacements, such as the door between the southeast parlor (Rm 112) and the kitchen (Rm 111).

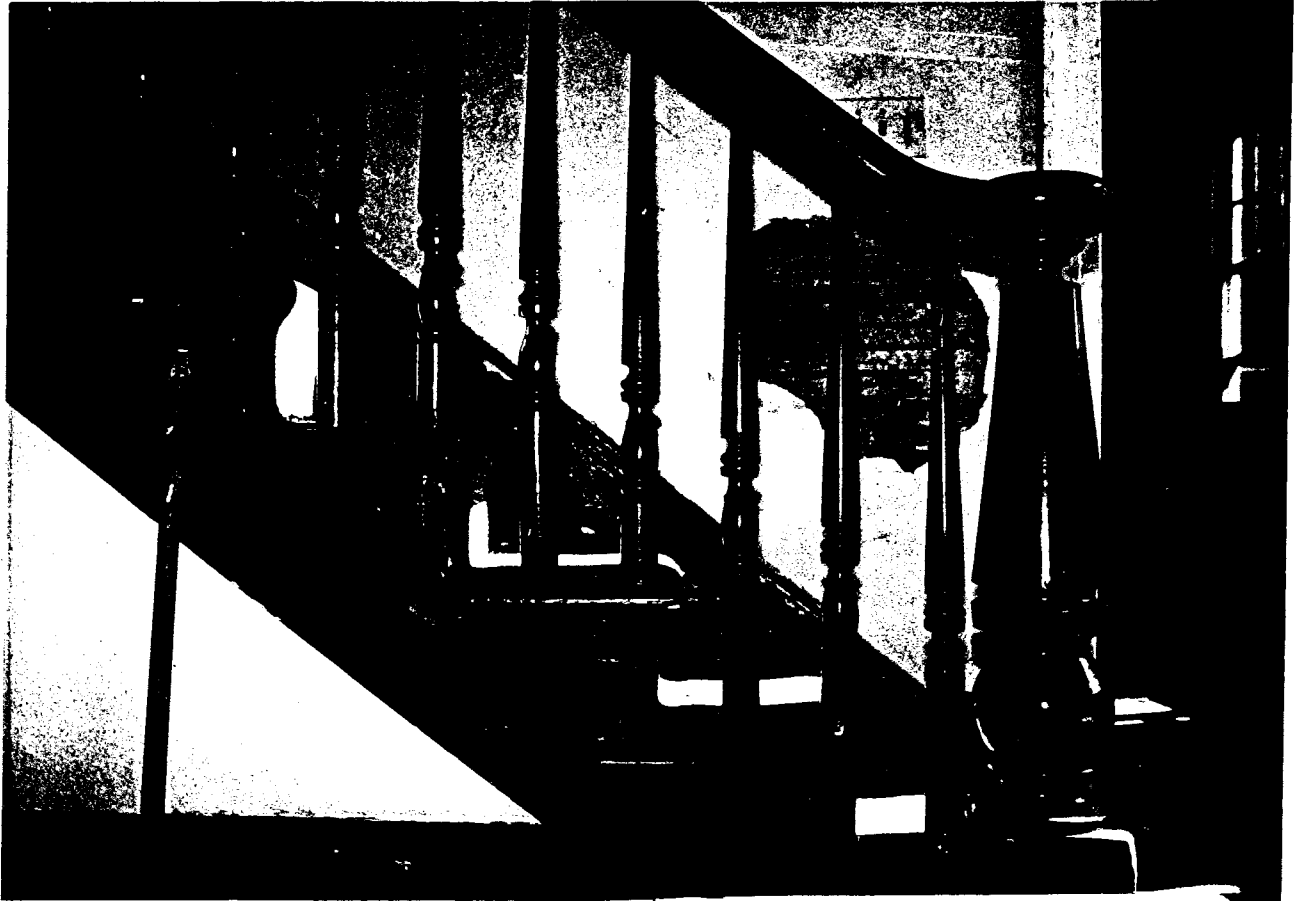
FIGURE 44

Room 101, stair detail

Note diagonal line on lath indicating previous location of stair.

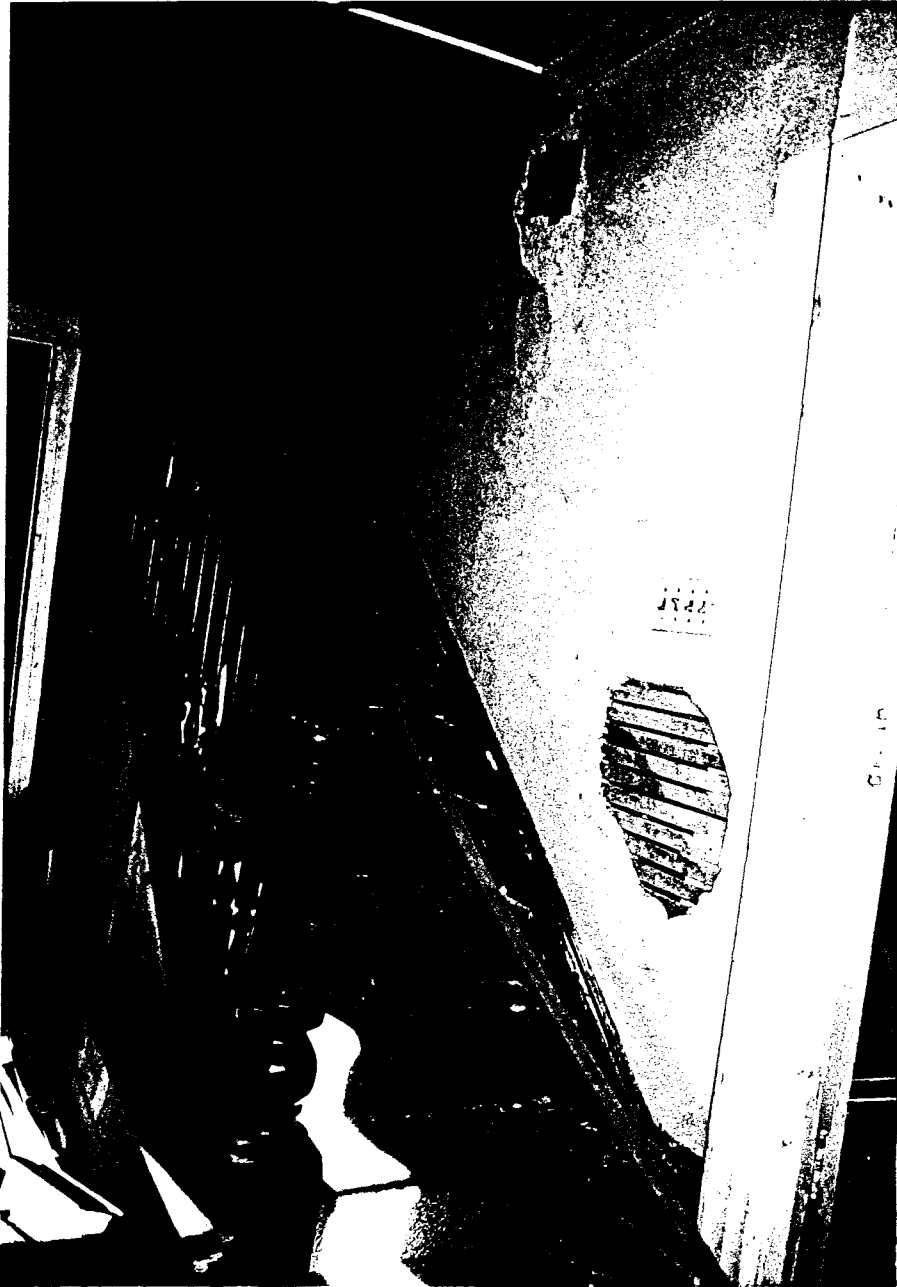
FIGURE 45

Room 101, stair detail

Note diagonal line on lath indicating previous location of stair.
