Acroterion

Ocean County Courthouse: Research and Renovation Plan

Ocean County Courthouse: Research and Renovation Plan To Date

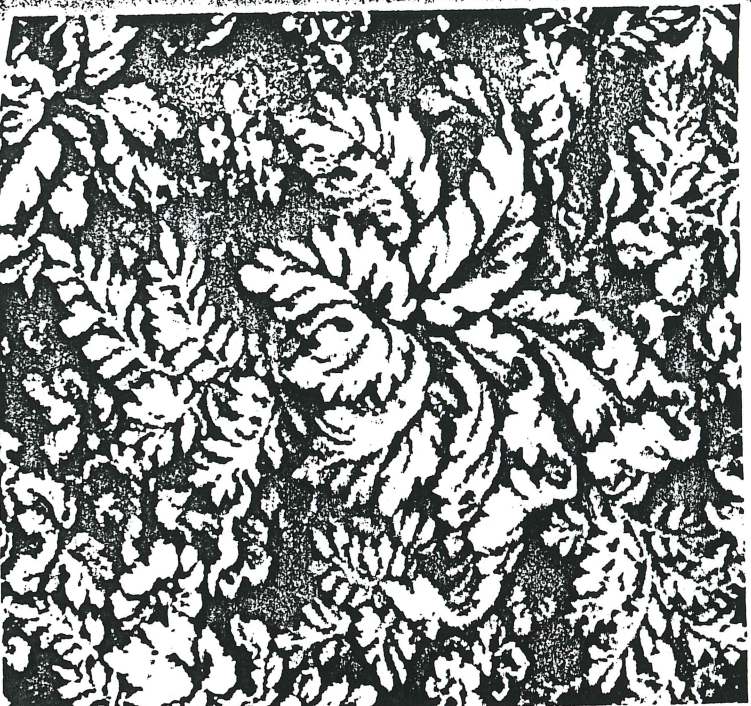
SNOWDEN. Wilton
carpet. Scalamandre.
Red with gold, yellow
and olive brown.

TURNER. Wilton
carpet. Scalamandre.
Custom colors.

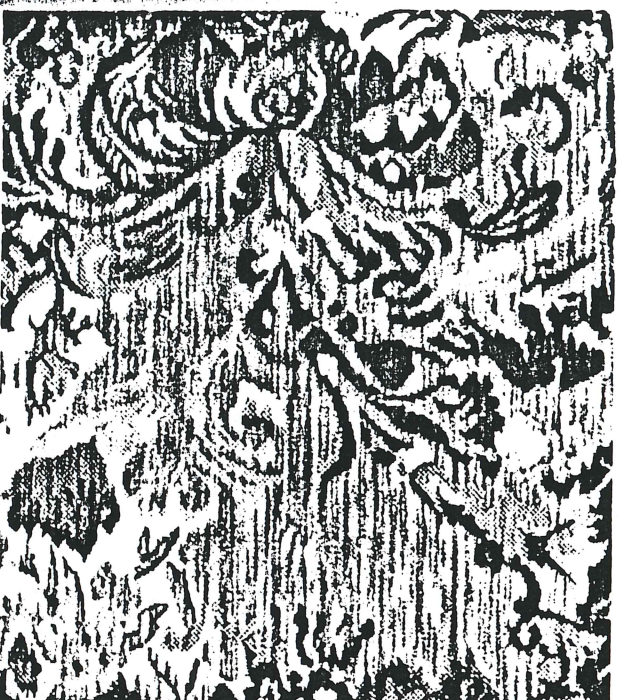
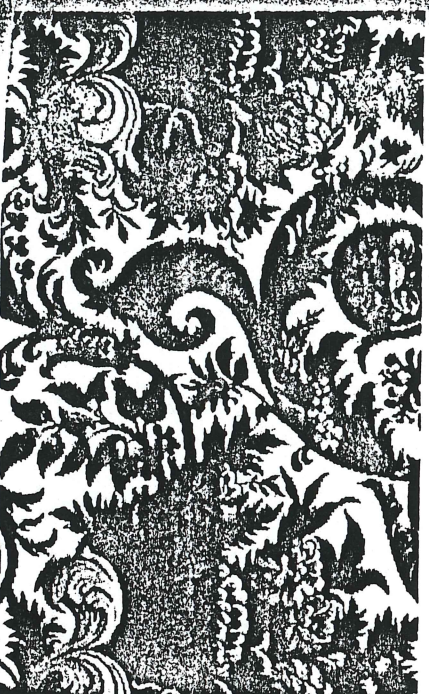
left
VICTORIAN TAPES-
TRY. Wilton adaptation
of tapestry velvet car-
pet. Langhorne Carpet
Company, Orange,
green, red, maroon,
brown, tan and blue.

below left
FLORAL WITH
ROCOCO LEAVES.
Wilton carpet. Patter-
son, Flynn and Martin.
Brown, orange, reds
and black on cream.

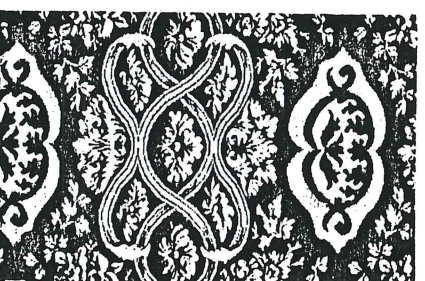
CARTOUCHE. Brussels
carpet. Patterson, Flynn
and Martin. Dark
brown with white, tan,
maroon and dark red.

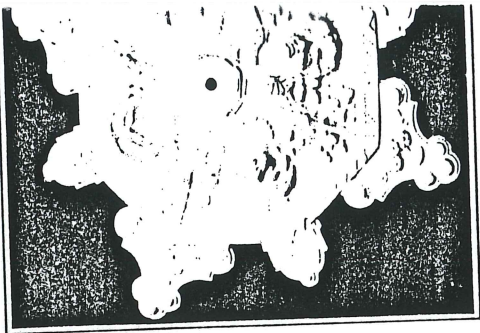
Plaster mouldings of the type in use 1870-90, including center medallions
highlighting light fixtures. (American Victorian)
