HISTORIC STRUCTURE REPORT
for
THE OLD OCEAN COUNTY SHERIFF'S OFFICE
Toms River, Ocean County, New Jersey

Prepared by
Watson and Henry Associates
Bridgeton, New Jersey
Project 88-055

January 1992

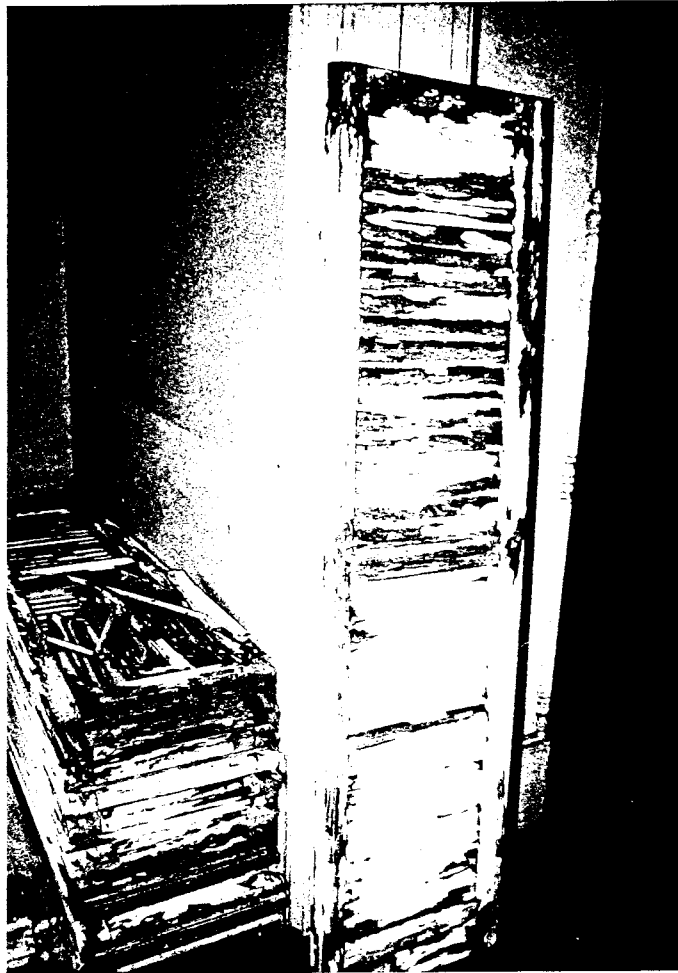
FIGURE 21
Shutters stored in building

Shutters for the south facade of the Old Sheriff's Office are stored inside the building (Figure 21). There are eight pair intact, and one shutter that has fallen apart. One shutter is missing.

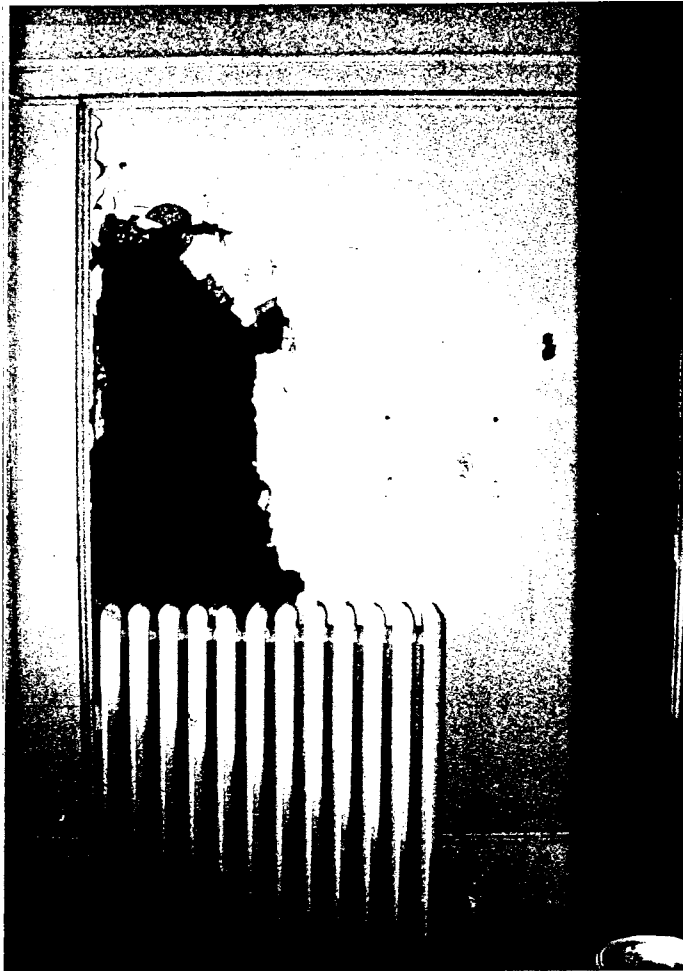
FIGURE 24

The archway between the southwest parlor and the center hall has been filled in with fiberboard on studs (Figure 24). This infill should be removed very carefully, while evidence of the former configuration is searched for. The extant 1923 drawings show an open arch divided into thirds by two round supporting columns. Evidence that this was built has not yet been found, but may be uncovered during selective demolition.

Archway infill, Room 101

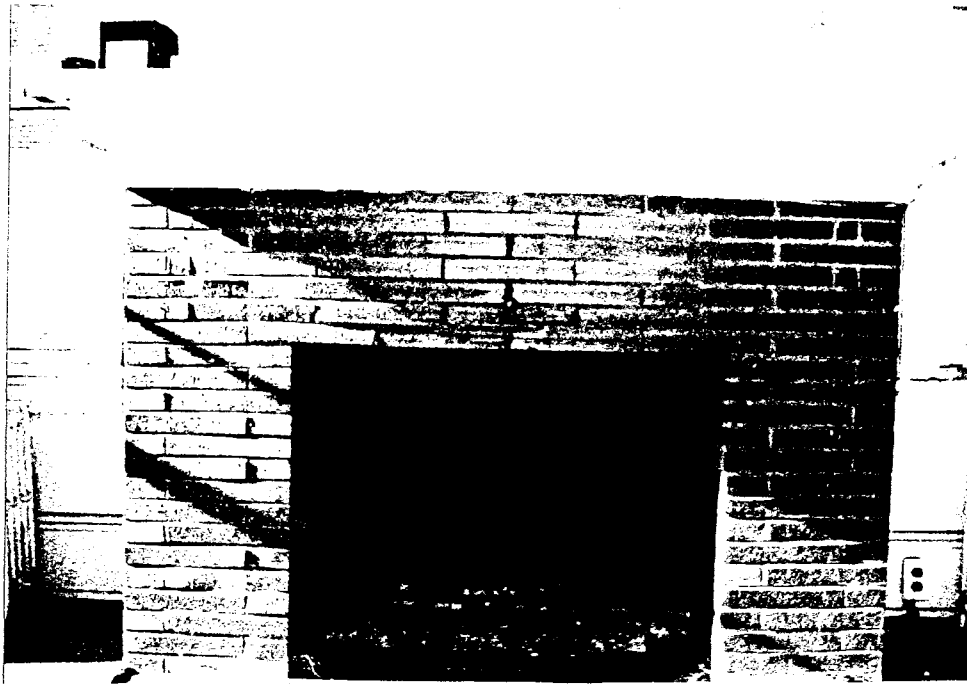
FIGURE 27

Only one fireplace remains following the 1923 renovation (Figures 27 and 47). This fireplace in the southwest parlor has a mantel, with carved brackets on the sides of the chimney breast (Figure 28). The face of the fireplace is built of Roman-style iron-spot brick. The fireplace is in good condition. However, the interior of the chimney was not investigated, and it should not be assumed that the fireplace is in working order.

Livingroom fireplace, Room 102

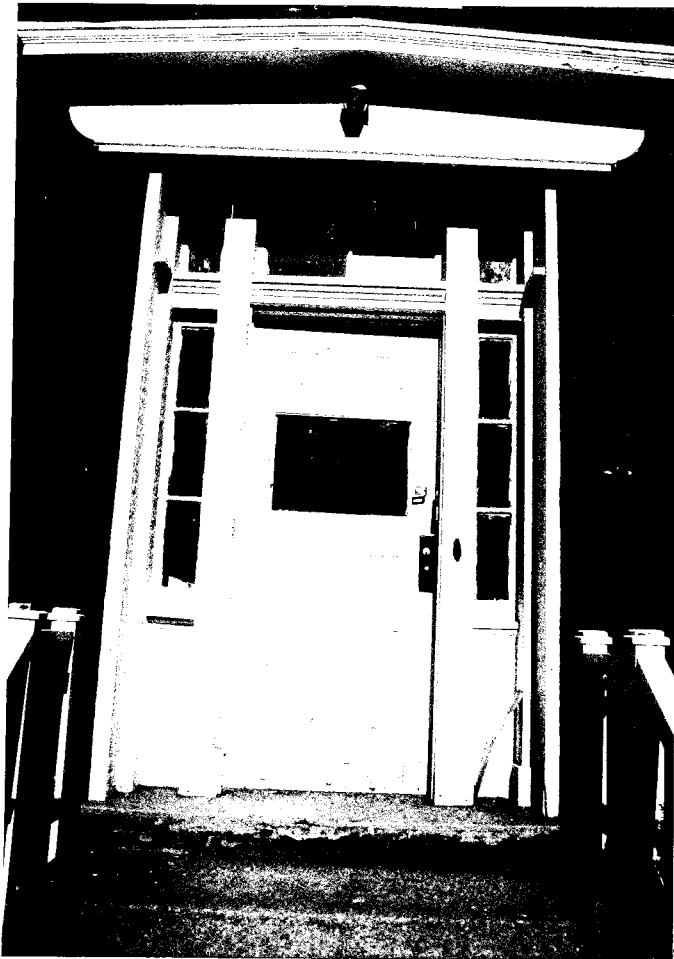
FIGURE 14

The 1923 Colonial Revival porch has been removed from the south facade. A shallow pedimented roof above an applied barge board has been installed above the front door (Figure 14). Concrete steps with wooden handrails have been built to provide access to the front door.

The front door is original to 1851 (Figure 14). The glass has been added, presumably since 1923, since there is no indication on the extant 1923 drawing regarding it.

Front entrance (South)

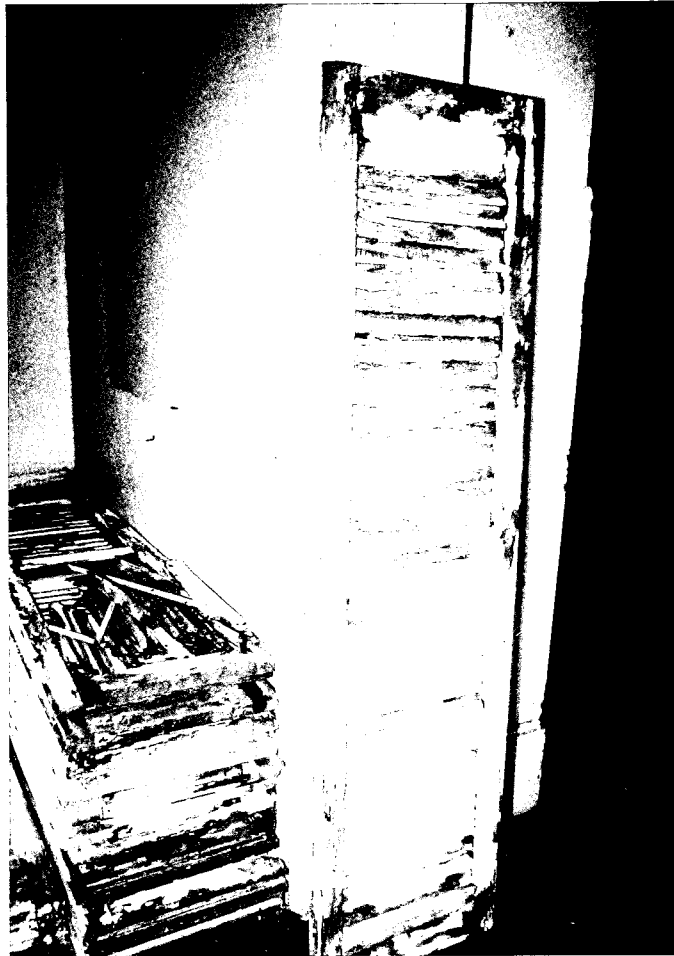
FIGURE 21

At present the building has no shutters in place. There are eight and a half pair of louvered shutters now stored in the Old Sheriff's Office (Figure 21); these are probably the ones that were taken off the building. There are holes in the building aligning with nails and holes in the shutters which indicate that in the twentieth century the shutters were nailed directly to the masonry on the south elevation. The shutters have a top layer of white paint over earlier dark green layers, with the bottom layer being black.

Shutters stored in building

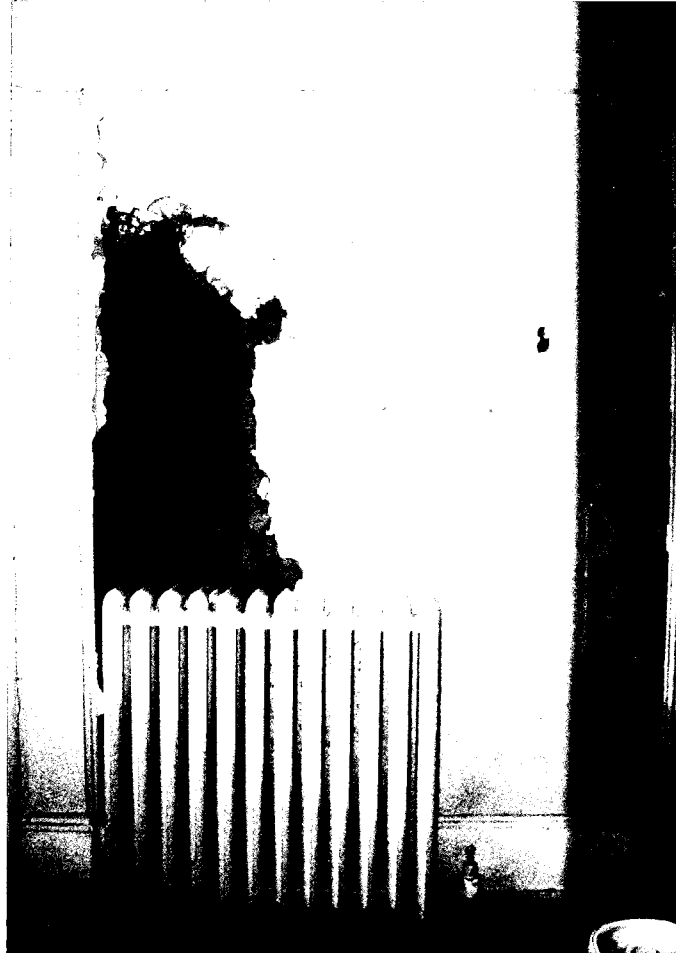
FIGURE 24

Most of the woodwork in the southwest parlor (Figure 26) dates from 1923, except for the window casings. However, the room as renovated at that time had an open archway on the east side. The archway was later filled in with particle board on studs (Figure 24). The glazed door now in the center of the previous archway appears to date from 1923; it may have been moved from another part of the house.

Archway infill, Room 101

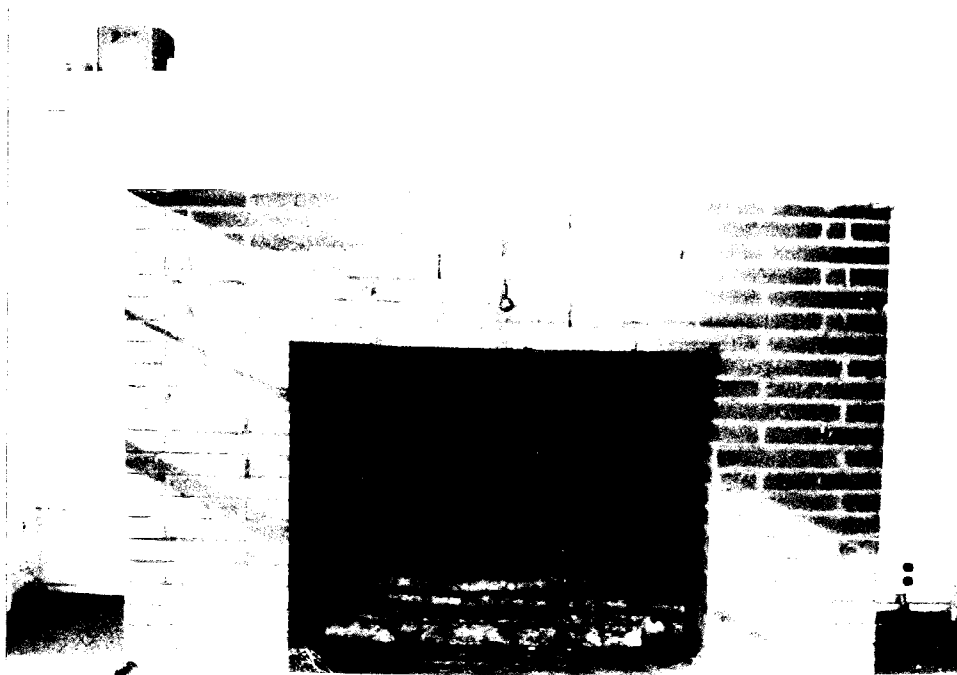
FIGURE 26

Room 102, Living Room

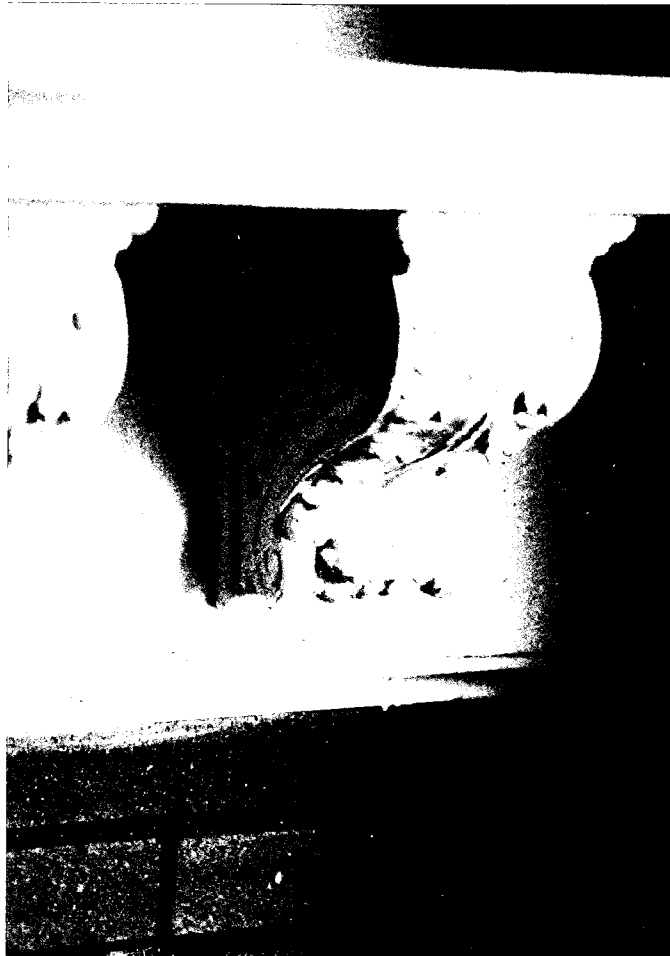
FIGURE 27

The Old Sheriff's Office originally had fireplaces in both of the south rooms on the first floor. The support arch and hearth framing for the fireplace in the southeast parlor exists in the basement (Figure 22). This fireplace was eliminated, and the fireplace in the southwest parlor was redesigned and rebuilt, in 1923 (Figures 27 and 28).

Livingroom fireplace, Room 102

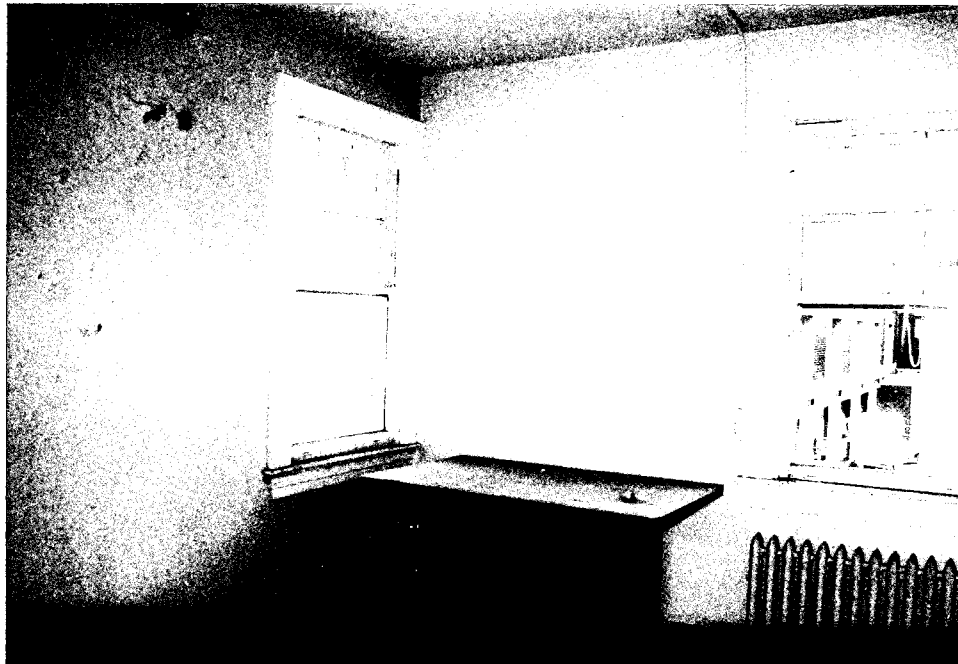
FIGURE 39

Detail of plumbing, Room 204
